Engineering UPDATE©

MARINO ENGINEERING ASSOCIATES, INC. • Issue 35

HYDROLOGIC IMPACTS ON AN UNDERGROUND ABANDONED COAL MINE

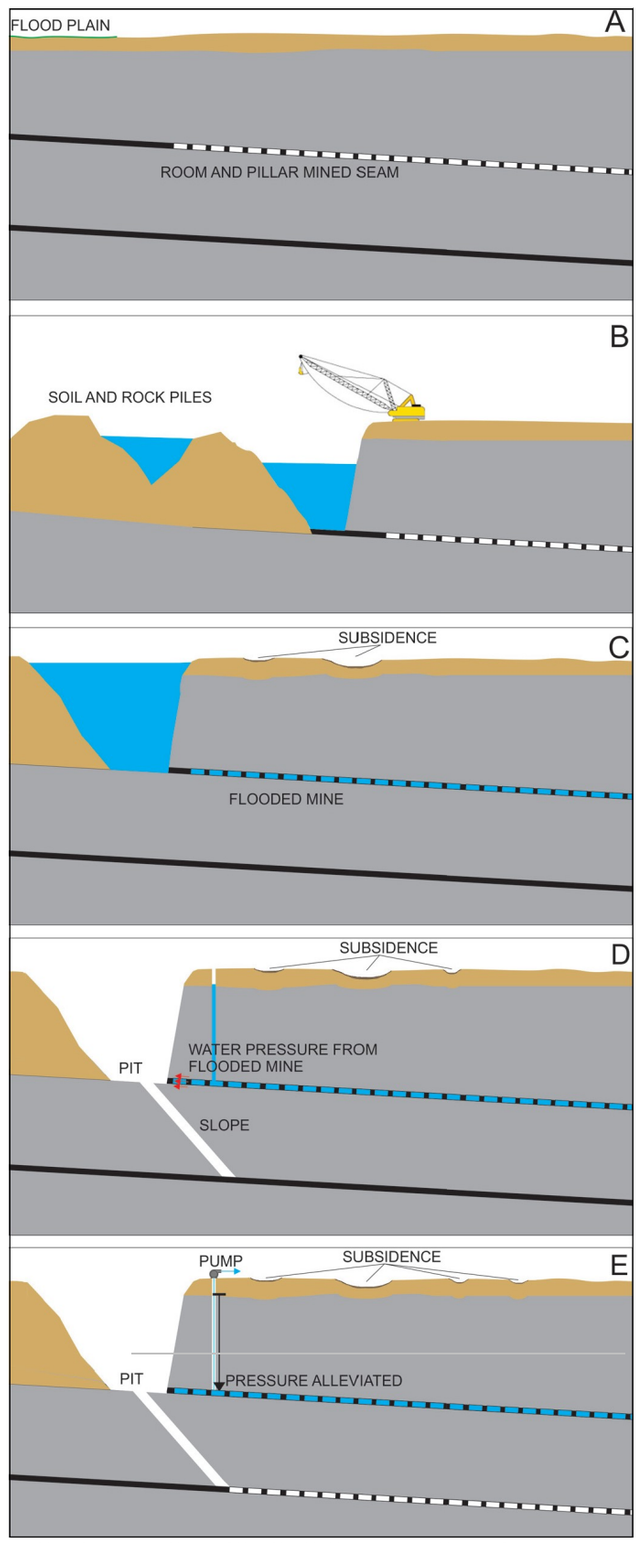
FIGURE 1 SNAPSHOTS OF MINING AND HYDROLOGICAL CONDITIONS OVER TIME

At shallower depths to the south, (due to the dip of the coal to the north), the coal seam was being stripped out in the area. This stripping operation was ongoing while the underground mining was taking place. See Figure 1B. The stripped area was in the lowlands, therefore significant amounts of runoff drained into the mined pit. This could be clearly observed on the historic photos of the area.

As a result of the dewatering, the water level was dropped as much as about 140 ft. over extended periods of time, but would vary depending upon the pumping effort. In other words, in addition to putting the full weight of the overburden back on the mine structure that had been subjected to long term moisture deterioration, the dewatering resulted in oscillating water levels causing cyclic slaking and roof cave conditions (see Figure 2). In effect, this roof deterioration would result in heightened pillars with reduced capacity. Given the now softened floors, reduced pillar capacity, and significant increase in overburden load from dewatering, a substantial increase in surface subsidence was observed. See Figure 1E.

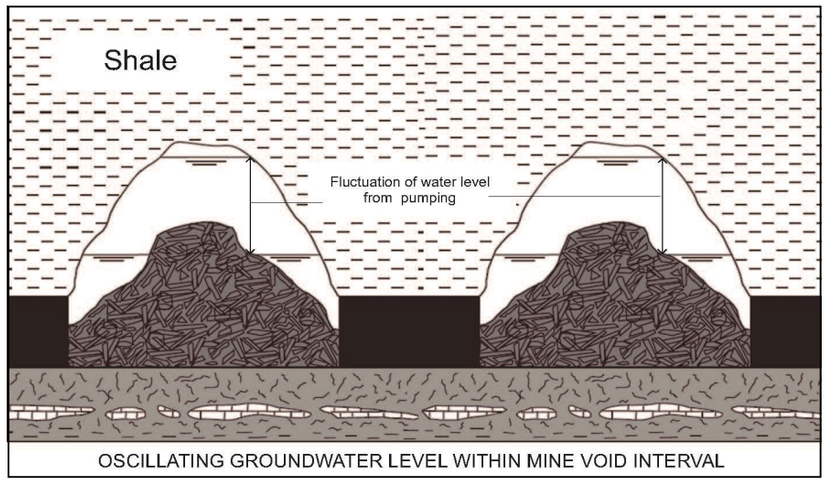
FIGURE 2 ROOF FAILURE ABOVE ROOM
