## ANATOMY OF CANAL GEO-CONSTRUCTION DIFFICULTIES

### PROJECT

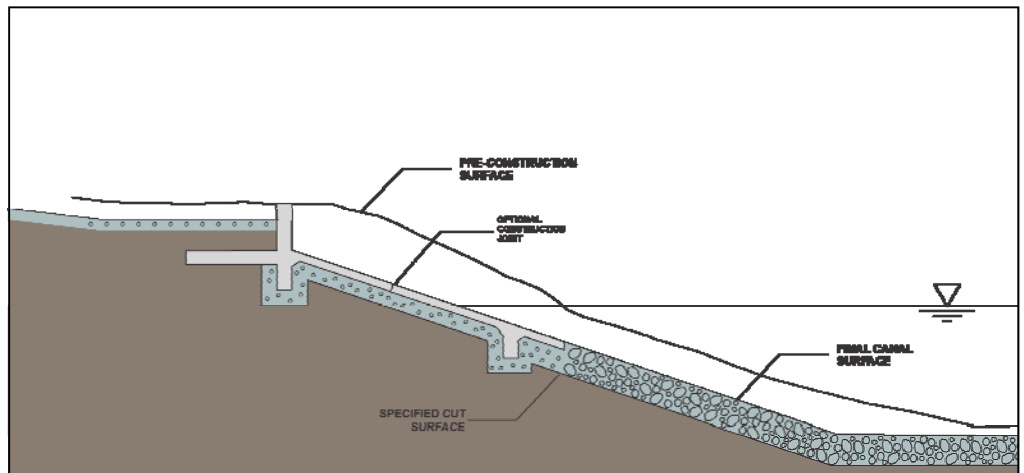
FIGURE 1: CANAL IMPROVEMENT TO BE CONSTRUCTED

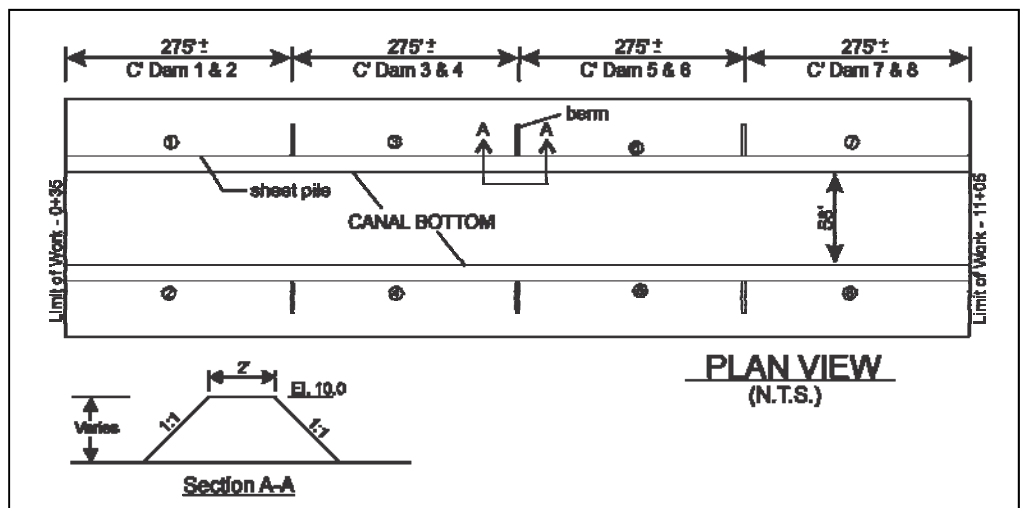
One of the methods specified under the contract to install the concrete apron was to create cofferdams in order to unwater areas along the canal bank. The cofferdam would be created by driving sheetpiling in the lower part of the canal slope with earthen berms at each end of the piling to create the enclosure. This is the method chosen by the contractor to perform the work. The contractor considered that eight, ± 275 ft. long cofferdams would need to be constructed (See Figure 2).

FIGURE 2: COFFERDAMS PLANNED TO BE CONSTRUCTED TO INSTALL CONCRETE APRON ON SLOPE
