## DEVELOPER AVOIDS SUBSTANTIAL RISK OF SUBSIDENCE DAMAGE

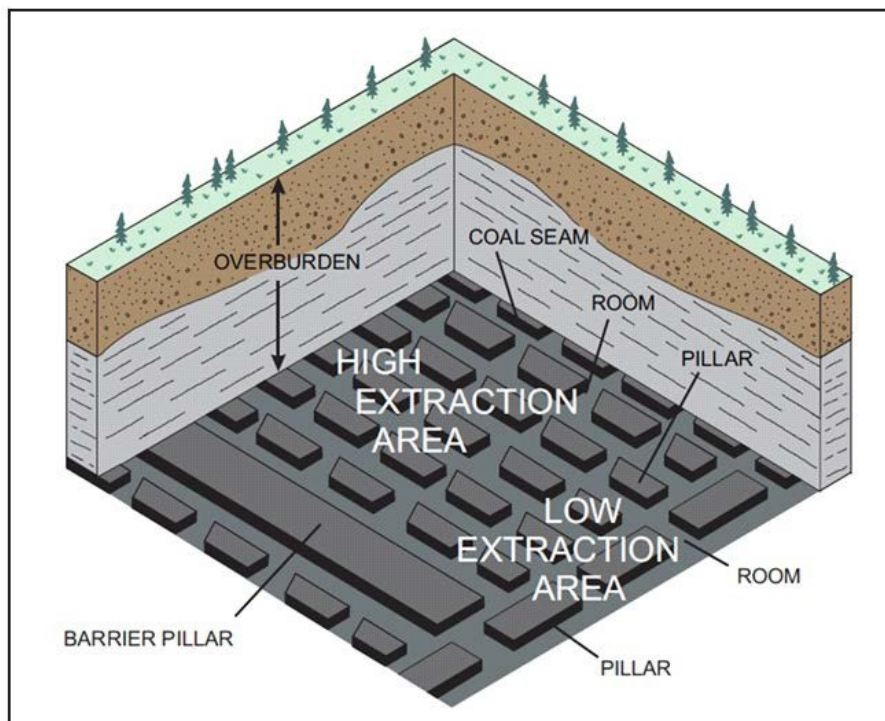
The method used to recover the coal is called room-and-pillar extraction. Here, the coal is extracted by excavating intersecting tunnels (also known as rooms or entries) while pillars of the remaining coal are left to support the overburden (Figure 1). A historical map showing the rooms and pillars left beneath the site is shown in Figure 2.

FIGURE 1: ISOMETRIC VIEW OF ROOM-AND-PILLAR MINES
