## MOISTURE SOFTENING EFFECTS ON MINE FLOORS

**ABOUT MEA:** Marino Engineering Associates, Inc. focuses on engineering research, practice and expert evaluations and is licensed in 25 states in the U.S. Our projects primarily have an emphasis on Geotechnical Engineering, however, we also have significant experience in projects involving transportation, subsidence engineering, laboratory testing, training, and geophysical exploration. Gennaro G. Marino, Ph.D., P.E., D.GE is president and principal engineer of Marino Engineering Associates, Inc., and has been a licensed professional engineer since 1984. To obtain additional information on MEA, one can also visit our website at [www.meacorporation.com](http://www.meacorporation.com).

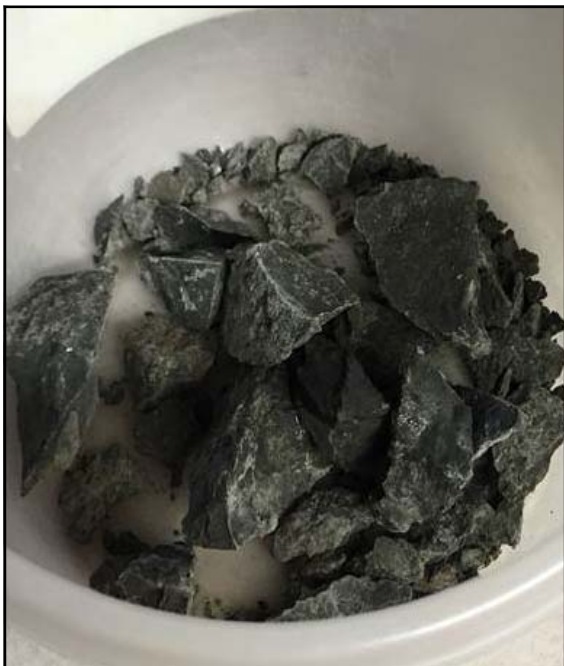
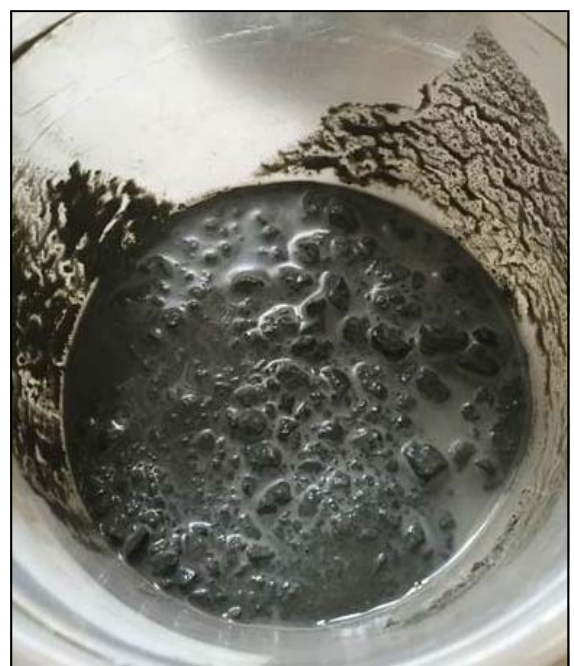
FIGURE 2 EXAMPLE OF EFFECT OF WATER EXPOSURE ON MUDSTONE

The potential for a floor to soften is dependent on geologic conditions. Here, sufficient strata lay beneath the coal bed (or other mine ore), which are susceptible to deterioration when exposed to moisture. These floor rocks are commonly classified as claystone, mudstone, or clayey shale. An example of the effect exposure to water can have on these materials is shown in Figure 2. But, the degree of the effect that moisture will have on these rocks depends on the mineralogical content. It is, however, important to note that this geological condition is not prevalent under coal beds in many areas. Where there are more durable floor rocks present, floor failure is rarely a concern. In a mine, the area which is most exposed to moisture from groundwater inflows is in the entries (openings), where the water pools onto the floor. Being unrestrained in the mine
