## BOREHOLE RADAR DETERMINES SOLID COAL AND MINED-OUT AREAS

MEA was asked to determine the effects of mining beneath a proposed roadway structure. In order to determine the subsidence potential and the magnitude of the mine stabilization costs, it is important to know whether underground mining is present, and if so, to what extent. The site investigated had the potential to have mining in three different coal seams. The Illinois Coal seams in question were the No. 7, No. 6, and the Seelyville ranging in depth from 70 to 300 ft.

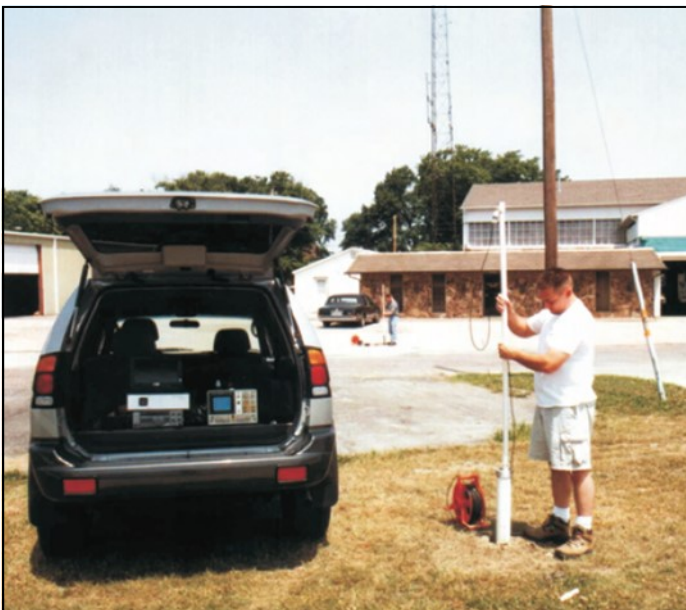
FIGURE 1 MEA BOREHOLE RADAR SYSTEM: ANTENNAS BEING LOWERED INTO BORINGS IN ORDER TO CONDUCT A CROSS-HOLE SURVEY

MEA's borehole radar system which was used on this project is shown in Figure 1. A borehole radar works particularly well for detecting solid coal and void areas because a coal seam is bounded above and below by materials with different electrical properties than that of the coal. Because of this, it is possible to use electromagnetic (radio) waves to detect anomalies in the coal seam. Materials such as shale, claystone, and mudstone generally have low resistivities on the order of 50 to 10,000 ohm-cm. Coal generally has a much high resistivity on the order of 20,000 to 80,000 ohm-cm. The dielectric constant of coal is generally lower than that of roof and floor materials, in the range of 5 or 6 as compared to 10 or greater for the roof and floor. These differences in electrical properties of the materials produce boundary conditions at the interfaces of coal-roof and coal-floor that allow a radio signal to be "trapped" in the coal seam and to propagate through the coal as in a waveguide. Therefore, a radio signal in solid coal will travel with less attenuation than in free space.

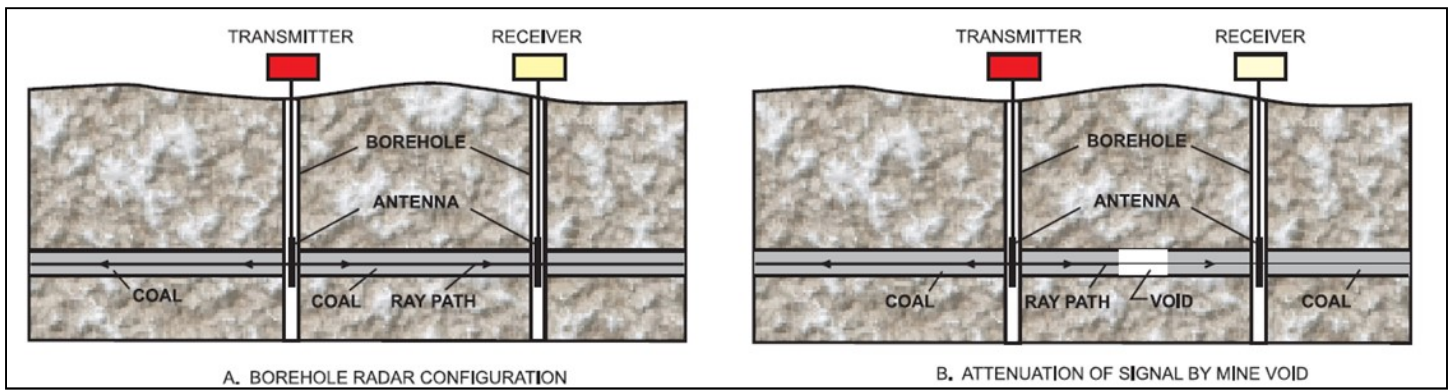
FIGURE 2 BOREHOLE RADAR SYSTEM SHOWING RAY PATHS AND ATTENUATION BY A VOID IN THE COAL SEAM

If two antennas are lowered down boreholes to the coal seam, a radio signal transmitted from one antenna will transmit through the coal to the receiving antenna with a certain attenuation rate (see Figure 2a)/ In a homogeneous coal seam this rate will be determined by the characteristics of the coal such as resistivity, moisture content, and coal seam thickness. In this case, the attenuation will be a function only of the distance between the antennas—the greater the distance, the weaker the signal.

The presence of a mined-out area (void) in a coal seam is an anomaly and will produce a greater attenuation for a ray path through or in the vicinity of the void (see Figure 2b). If the void is close to but not directly in the ray path, there will be a small increase in attenuation of the signal.

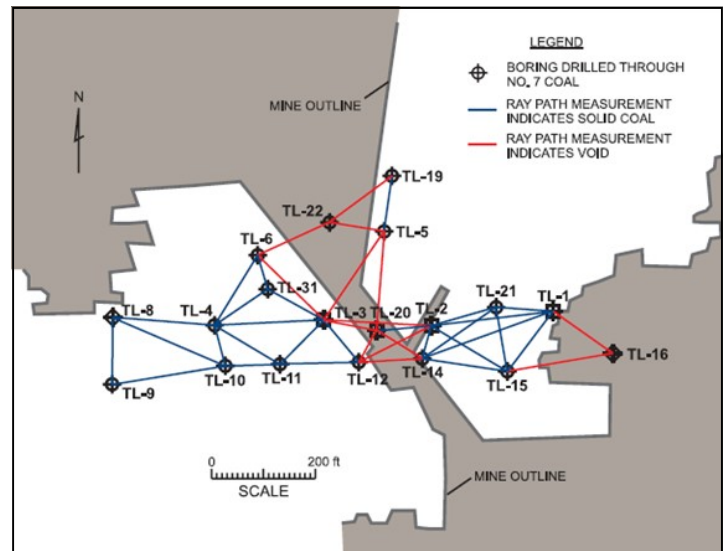
FIGURE 3 RAY PATHS BETWEEN BORINGS MEASURED WITH BOREHOLE RADAR IN THE NO. 7 COAL AT THE PROJECT SITE

The results obtained in the No. 7 Coal seam are summarized in Figure 3. There were 41 ray paths taken in this coal seam. All the measurements except two (TL-2/TL-6 and TL-2/TL-20) confirm the mine outline. In order to assess the indication of mining between TL-3 and TL-6, a supplement boring was drilled (TL-31). Measurements from this hole showed solid coal. Consequently, it was concluded that mining was in the vicinity of TL-3/TL-6 ray path but it did not proceed southwest (see Figure 3). The other anomalous ray path measurement indicated no mining where it clearly existed based on the mine map and a number of other ray path readings. This anomalous reading was attributed to electrical resonance from the relative orientation of steel roof support (probably left in the main rooms in this section of the mine) and the ray path.
