RISK INVESTIGATION OF KARST ON SINKHOLE/SUBSIDENCE PRONE LANDS

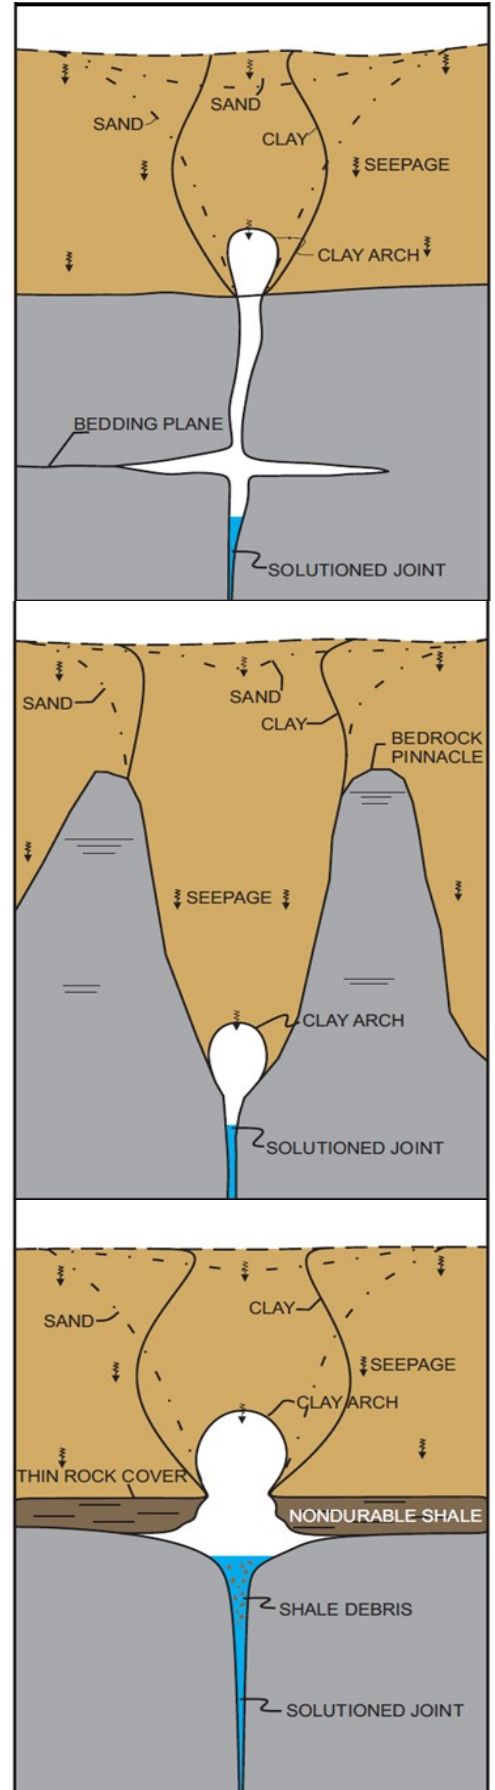
FIGURE 1 TYPICAL KARST SUBSIDENCE SCENARIOS

The vast majority of the surface subsidence results from shallow bedrock karst features (aka epikarsts). The more typical karst-subsidence scenarios are illustrated in Figure 1. Once the voids in the bedrock have formed, the downward raveling or piping (washing) of the soil cover can be induced by groundwater seepage. Downward seepage results from significant precipitation, or the lowering of the groundwater table. This results in groundwater flowing laterally and up or down through voided fractures. From the soil piping or raveling into the solution features below, a depression forms on the ground surface. These subsidence events form into sinkholes (or pits), or sags (dish-shaped depressions). The surface expression from epikarsts depends on if the soil cover acts as a cohesive (e.g. clay) or cohesionless (e.g. sand) material.

With a cohesive cover, as soil is washed down into the bedrock void, a soil arch forms and over time becomes larger as it progresses upwards toward the ground surface. See Figure 1. As the arch approaches the ground surface, it collapses causing a sinkhole to form. This phenomenon is called a cover collapse. For risk analysis, it is critical to identify the susceptibility of the site to cover collapse. Such events in epikarsts can abruptly occur with little warning, resulting in typically up to 30 ft. diameter sinkholes of considerable depth, thus undermining building foundations, creating hazards, and potentially draining detention/retention ponds.

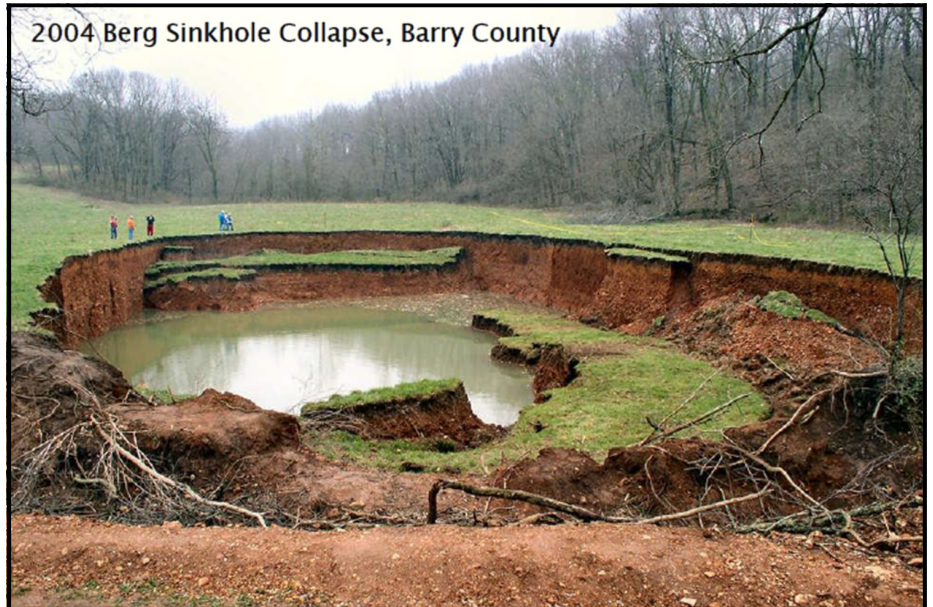
FIGURE 2: LARGE SINKHOLE FROM A LIMESTONE CAVERN COLLAPSE (COURTESY OF UNIVERSITY OF MISSOURI, 2012)

Deep seated cavity collapse results in catastrophic subsidence events, but they are very infrequent. Such a collapse can be associated with a significant change in the groundwater table. An example is shown in Figure 2. These dramatic events usually make the news. However, the potential for such an event is often not investigated, due to the costs and because they are unlikely to occur.
