MEAA MARINO ENGINEERING ASSOCIATES, LLC. • Issue 63

SUBSIDENCE RISK OVER LIMESTONE QUARRY MINES

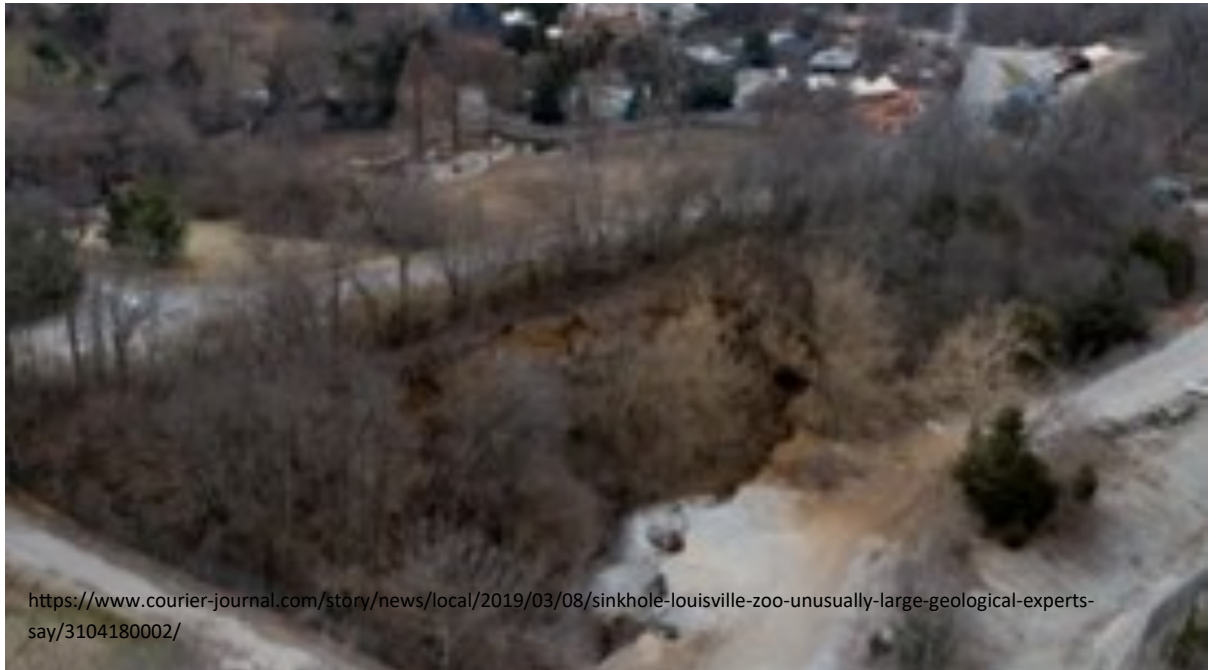
FIGURE 1 40FT CRATER WHICH FAILED OVER A LIMESTONE MINE

Most subsidence events from limestone mines are catastrophic and can even result in a seismic event felt in the area. These events typically have surface depressions which are 10's of feet deep with severely faulted to steep walled circumferences. See Figures 1 and 2. This significant drop of the ground surface is mostly related to the great extraction heights in the limestone formation or resource. Depending on the failure at mine level these depressions can go up to 100's of feet across.

When the roof rock caves into the mine void or entry, the roof failure can progress upwards until it reaches either stronger bedrock or the expanded volume of collapsed rock or cave chokes off preventing further upward collapse. This mechanism of roof failure is called chimney subsidence, and typically results in a deep sinkhole at the ground surface. See Figures 1 and 3.

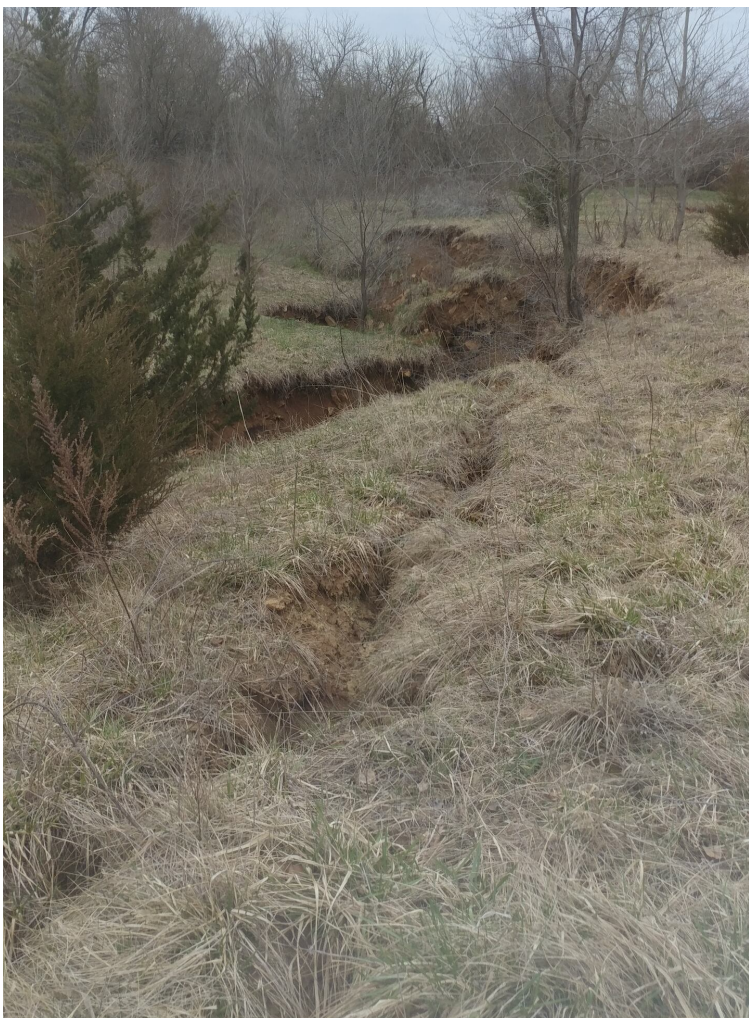
FIGURE 2 FAULTED EDGE OF SUBSIDENCE OVER A LIMESTONE MINE
