## CONSTRUCTION SLIDE CAUSES SIGNIFICANT DELAY AND ADDED COSTS

Presented herein is a case example of construction earth movement. The case exemplifies the significant effect such an event can have on the completion cost/time. This project involved the construction of a river intake facility to provide drinking water to area communities. To provide access to river water, two 3 ft. horizontal steel pipes were to be installed from the wet well, through the riverbank, and laid on the river bottom to the point of intake (see Figure 1).

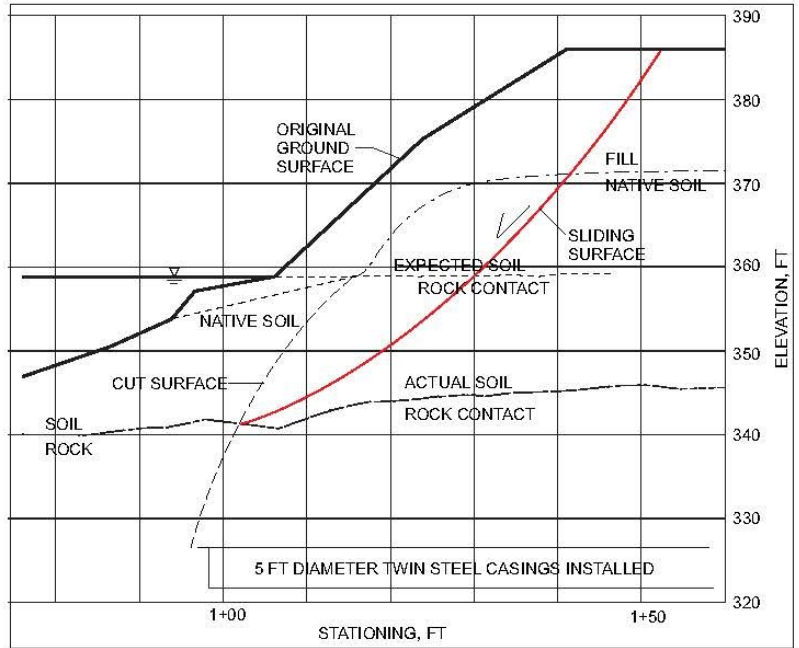
The design of how the construction was to be accomplished was left to the bidding contractor without any significant technical review of how the installation would be done. The contractor chose to install the intake pipes by constructing two 5 ft. diameter cased horizontal bores from the wet well to near the riverbank face. The 3 ft. intake pipes would be installed inside these bores. The remainder of the intake pipe would be installed by subaqueous excavation from the riverside. Consequently, this would require underwater excavation into the riverbank to connect to the pipe installed from the wet well. This pipe intake construction methodology was allowed under the contract, and this methodology seemed feasible based on the available design borings which indicated that bedrock was at an elevation which would adequately support the overlying soils when the riverbank excavation was made (see Figure 2).

The contractor subaqueously advanced the excavation into the riverbank, but due to the limited visibility conditions, there was no warning that the soil portion of the slope was unknowingly undermined as the bedrock surface was significantly lower than anticipated (see Figure 2). Ultimately, this resulted in two successive slides (see Figure 3) and a halt in the project due to potential retrogressive movements encompassing the adjacent 4-lane state highway. During construction, none of the slope stability issues were analyzed by any of the project team members. After much time and expense, the project was eventually complete.

FIGURE 2 SOIL/ROCK PROFILE AT THE RIVERBANK

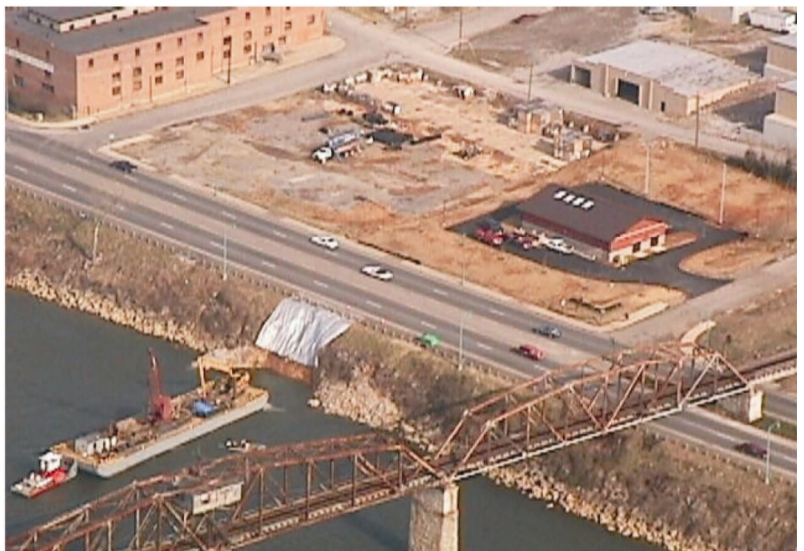
FIGURE 3 PHOTOGRAPH SHOWING THE RESULTING SLIDE FROM RIVERSIDE EXCAVATION
